Tree Management
Muree Golf Club

August 2016 Report

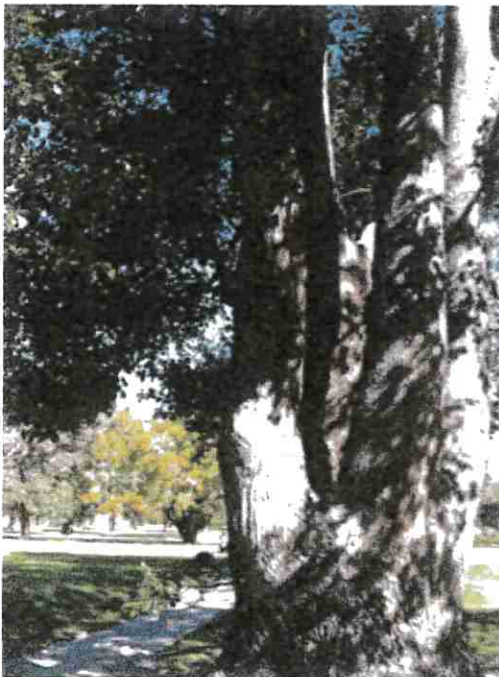
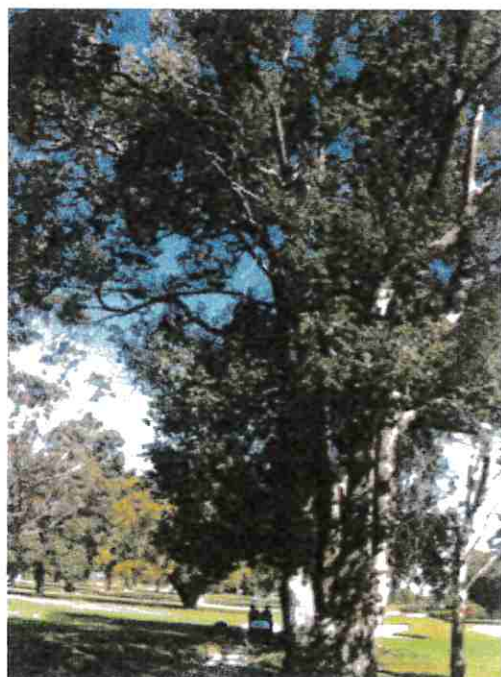
1st Fairway: A Camphor Laurel that is adjacent to the bunker of the left of the 1st green has been struck by lightning. Discussion around whether the entire tree should be removed resulted in an agreement to remove the large branch that has sustained the lightning strike in the hope that the tree will recover.

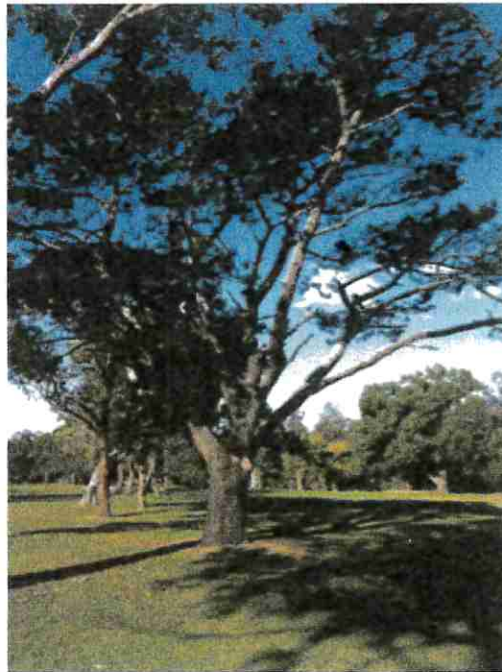
2nd Fairway: Approximately 100 metres from the 2nd tee, on the right hand side of the fairway, is an old Radiata Pine that has become unsafe due to dieback on most of the limbs of the tree. The dead limbs present a hazard to golfers and course staff as they may fall without notice and have the capacity to severely injure anyone underneath or close to the tree. The Committee has agreed that this tree in its present condition, must be removed. Discussion regarding replacement of this tree centred around using a native flowering tree such as a medium size Grevillea like Moon Shadow or Honey Gem.

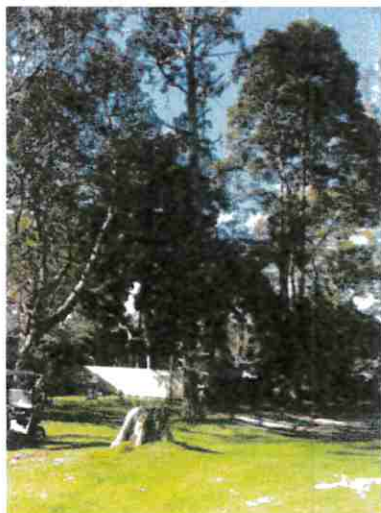
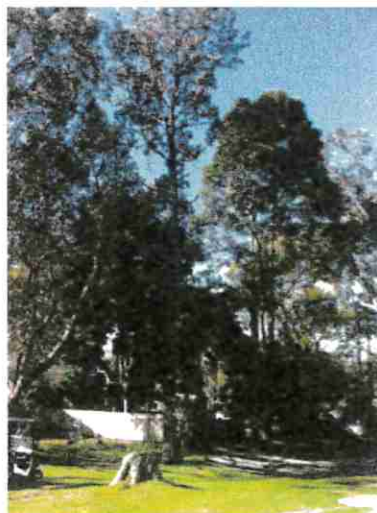
2nd Green: On the left hand side of the 2nd green there is a very tall, top heavy Grevillea Robusta. This tree has two issues that need to be addressed. The roots are impacting on the green and the surround turf and the tree is precariously leaning towards two neighbouring homes. The Committee all agreed to the removal of this tree, however the use of a professional tree surgeon is recommended due to the proximity to neighbouring homes. No replacement tree should be considered for this site.

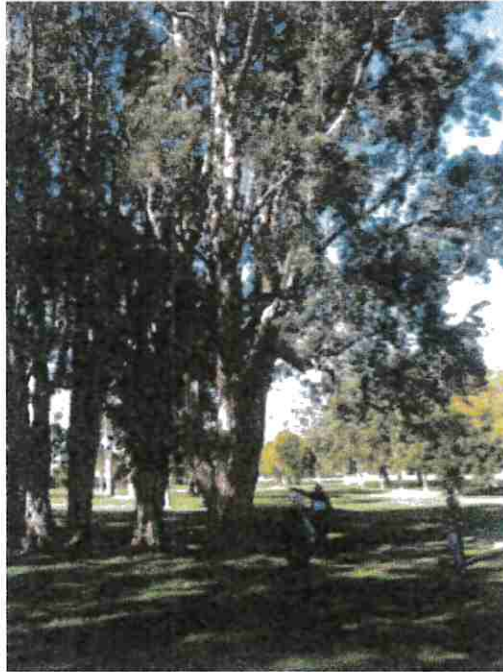
3rd Green: The right hand side of the 3rd green has a number of very large Melaleucas that prevent sunlight and draw nutrient and water from the green. There were a number of options considered and after a lengthy discussion that involved removal of up to five of the trees, it was agreed to remove the closest tree to the green only. This decision may have to be revisited should the growth of the green and surrounding turf not sufficiently recover. Consideration was also given to removal of the first two (of the three) mounds in front of the right hand side of the green and construction of a bunker to replace the mounds.

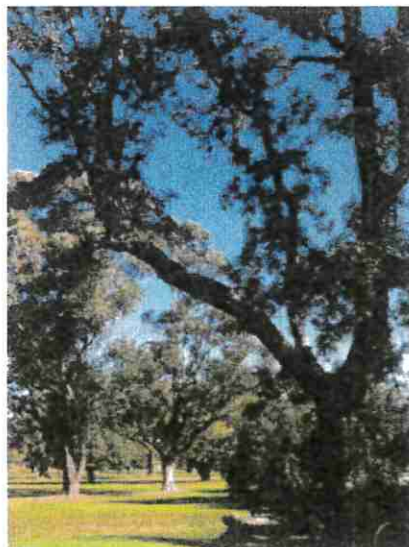
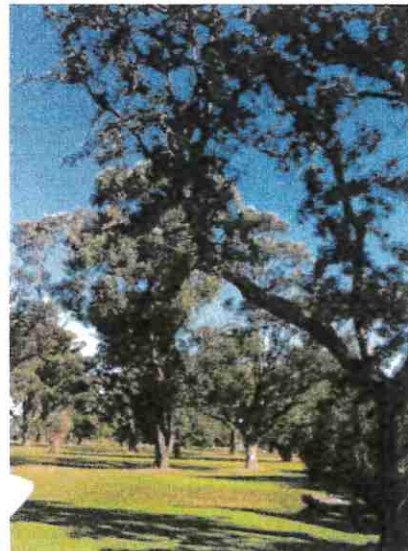
4th Tee: To the rear of the 4th tee (not the shared 4th & 18th tee) is a very large Grevillea Robusta. There is a large branch that hangs out over the tee that is considered to be dangerous and presents a hazard to members. The Committee agreed that the branch should be lopped and if possible, remove other dead branches from the tree as these also present a hazard to passing golfers.

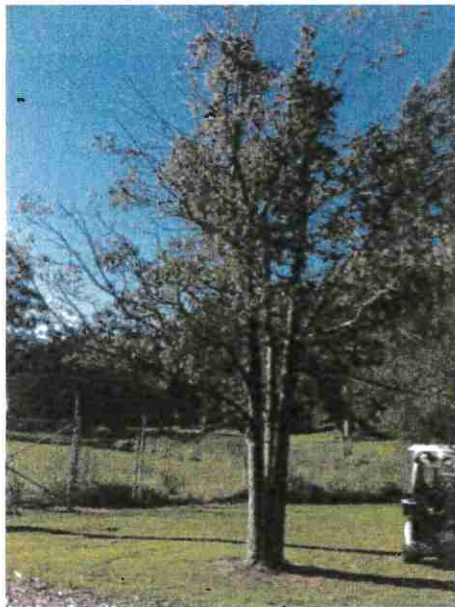
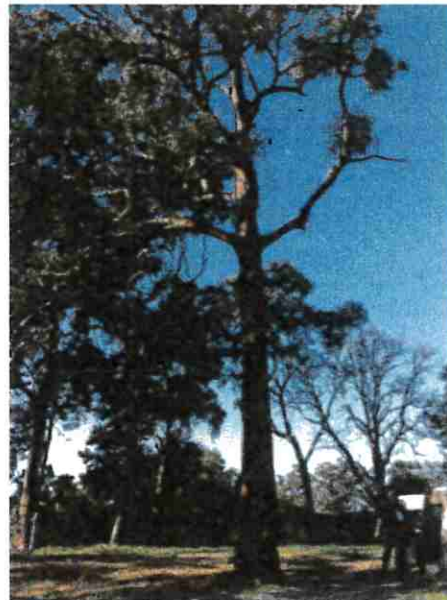
5th Fairway: The left hand side of the 5th fairway 15 metres back from the bridge to the 5th green, is a Camphor Laurel which appears under considerable stress. The tree has no impact on the rating of the hole and will be in the way of the proposed new path and bridge. The Committee agreed that removal of the tree should be undertaken with no replacement considered.

5th Green: The left hand side of the path around the 5th green is a large eucalypt that has been fatally struck by lightning. The tree presents hazard to all that use the path and the Committee agreed to its removal. No replacement was considered.

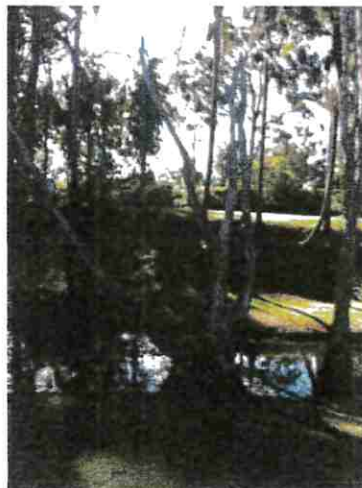
6th Fairway: Along the creek after the bridge crossing to the 12th tee are a number of melaleucas that are either dead or have branches that have fallen into the creek. It was agreed that these should be removed. Care should be taken not to damage remaining melaleucas as their removal will impact on the rating of the hole.

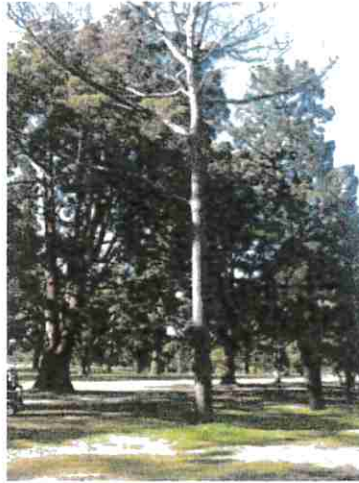
8th Hole: On the right hand side of the 8th, is a tall radiata pine that is dead (likely from the number of times I have hit it!). The Committee agreed to the removal of this dead tree.

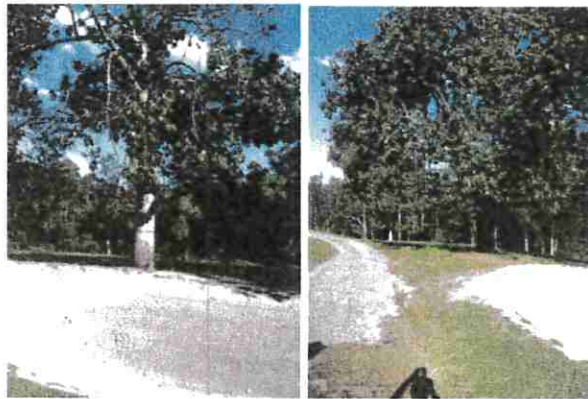
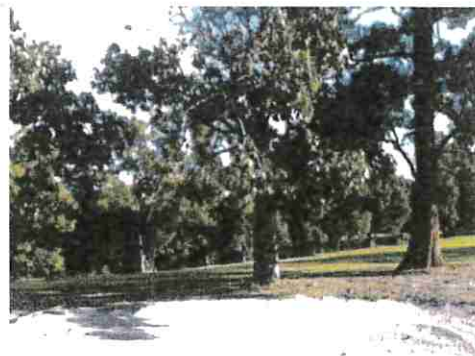
11th Fairway: The first of the Swamp Mahogany eucalypts on the right hand side of the 11th fairway has a strangler fig growing in the crutch. The committee agreed that removal of this fig should be done as quickly as possible.

There are three trees to the right hand side of the 11th green, all the same genus (although what that is we are uncertain), that have severe dieback in most limbs. The Committee agree that these three trees should be removed although it is likely that a commercial service provider should be used to do this work.

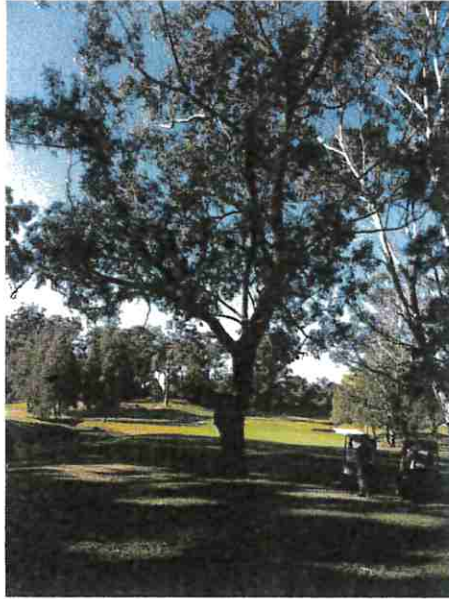
12th Fairway: Before the start of the fairway to the 12th hole is a eucalypt that has severe die back. The tree presents a hazard to golfers and course personnel as there have already been instances of falling limbs. The Committee agreed that removal of this tree is mandatory.

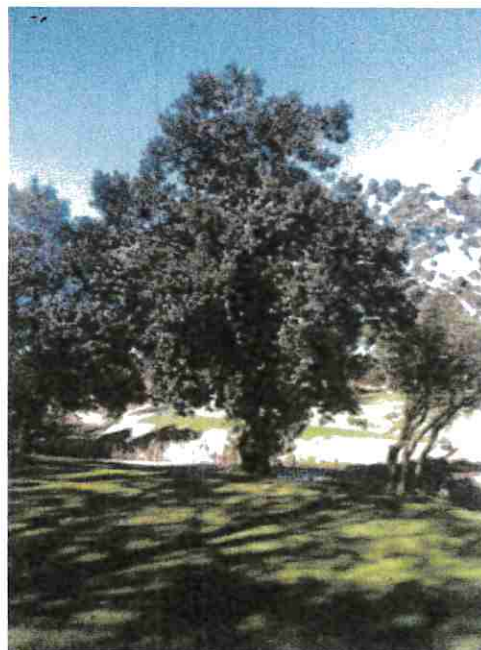
17th Tee: To the rear of the 17th tee, there is a strangler fig that has consumed a banksia. The fig will only become a burden for both the path to the 5th tee and block the sun from the 17th tee. The Committee agreed to the removal of the fig.

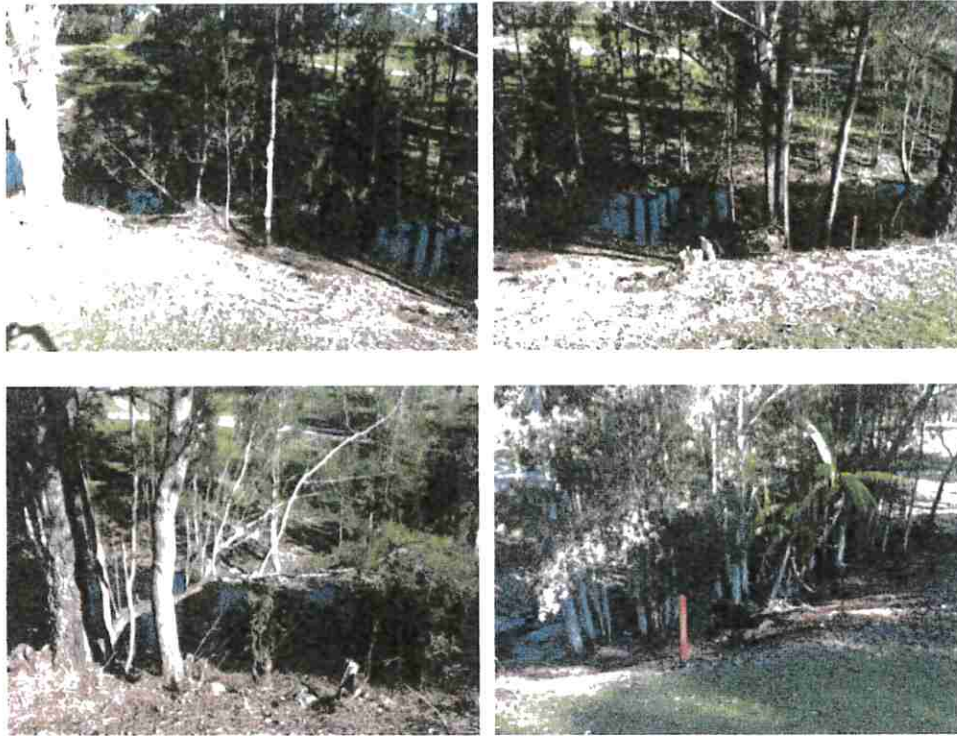
17th Tee: The southern side of the 17th tee has become overrun by paperbark and casuarina saplings. These saplings have choked the waterway consequently it was agreed by the Committee to remove all the saplings, while retaining the larger more mature trees.

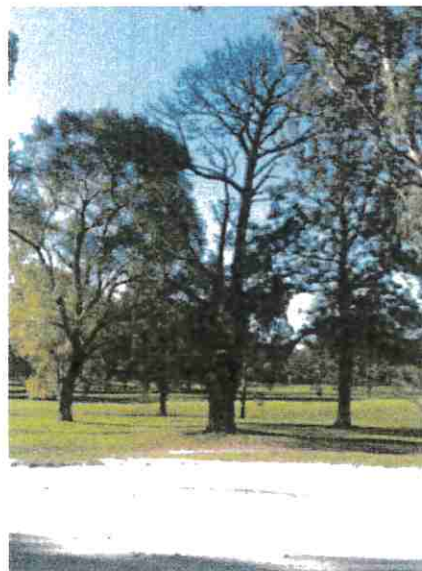
17th Fairway: There is a radiata pine that has reached it's end of life and has become a hazard due to dead limbs. The Committee agreed that this tree should be removed.
